Manhole Inspection Summary

Manhole # S31EE_015MH

Insp Date: **1/25/07 9:32 AM**

Location Address: **201 PRESTON ST**

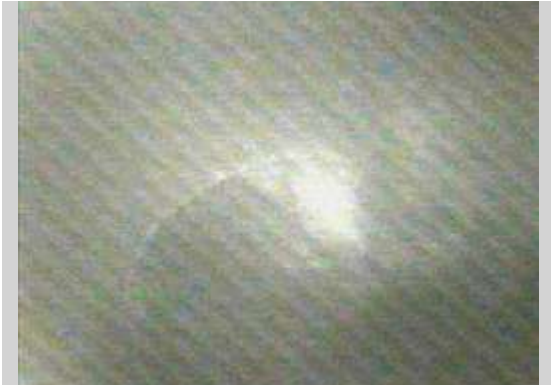
12 in. Circular Gravity Sewer Pipe Out @ 12 O'Clock

Invert Depth: **17.70** (ft.) Flow Characteristics: **Turbulent**

Deposits: ☒ None ☐ Mud ☐ Sludge ☐ Debris ☐ Grease

Infiltration: **None** Pipe Seal Cond: **Unknown**

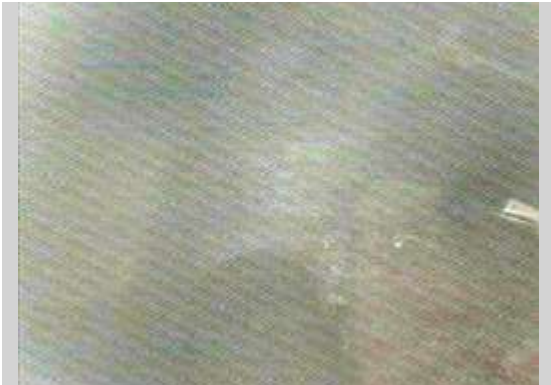
12 in. Circular Gravity Sewer

Invert Depth: **16.06** (ft.) Flow Characteristics: **Turbulent**

Deposits: ☒ None ☐ Mud ☐ Sludge ☐ Debris ☐ Grease

Infiltration: **None** Pipe Seal Cond: **Unknown**

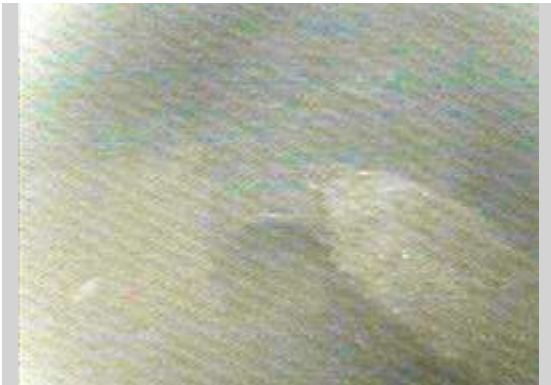
8 in. Circular Gravity Sewer

Infiltration: **None** Pipe Seal Cond: **Unknown**
